DEPARTMENT OF TRANSPORTATION**DIVISION OF ENGINEERING SERVICES**

Office of Structural Materials

Contract #: 04-0120F4Cty: SF/ALA Rte: 80 PM: 13.2/13.9File #: 69.28**WELDING INSPECTION REPORT****Resident Engineer:**Pursell, Gary**Address:** 333 Burma Road**City:** Oakland, CA 94607**Report No:** WIR-001195**Date Inspected:** 03-Jan-2008**Project Name:** SAS Superstructure**OSM Arrival Time:** 930**Prime Contractor:** American Bridge/Fluor Enterprises, a JV**OSM Departure Time:** 1700**Contractor:** Zhenhua Port Machinery Company, Ltd (ZPMC), Changxing Island **Location:** Shanghai, China**CWI Name:** See Below**CWI Present:** Yes No**Inspected CWI report:** Yes No N/A**Rod Oven in Use:** Yes No N/A**Electrode to specification:** Yes No N/A**Weld Procedures Followed:** Yes No N/A**Qualified Welders:** Yes No N/A**Verified Joint Fit-up:** Yes No N/A**Approved Drawings:** Yes No N/A**Approved WPS:** Yes No N/A**Delayed / Cancelled:** Yes No N/A**Bridge No:** 34-0006**Component:** OBG**Summary of Items Observed:**

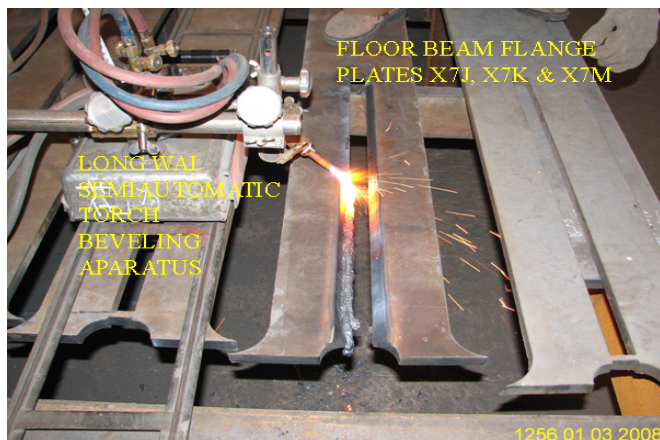
The QA Inspector randomly observed ZPMC Torch Cutting Operator Ms. Shi Gui Ju, utilizing a Long Wai track mounted Semiautomatic Torch Cutting Apparatus to cut the bevels in Floor Beam Flange Plates X7J, X7K and X7M. The attached photograph provides additional detail.

The QA Inspector asked ZPMC CWI Cui Yi Ru why the bevels had been changed to the inside of Floor Beam Flange Plates X7J, X7K and X7M. Mr. Cui informed the QA Inspector that the ZPMC Technological Department had made the change; but there was no explanation given to the QA Inspector as to why the ZPMC Technological Department made the change.

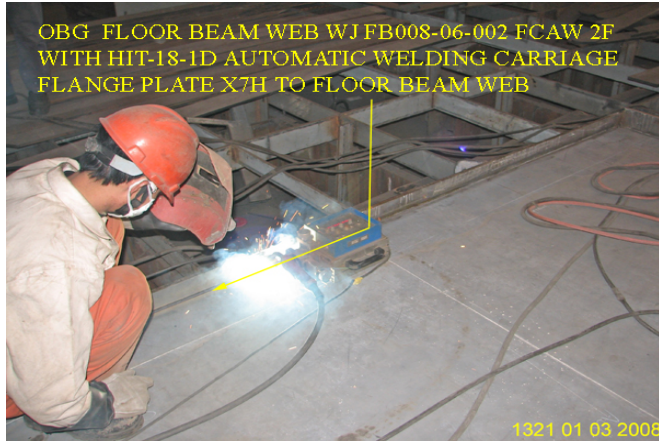
The QA Inspector randomly observed ZPMC welder Yuan Wensong ID Number 055491, utilizing the FCAW Process with ZPMC approved WPS WPS-B-T-2132-3 in the 2F position to weld Flange Plate X7H WJ FBO08-06-002, to Floor Beam Web FB008-06. The QA Inspector randomly observed ZPMC CWI Li Zhijiang, monitoring weld parameters. The QA Inspector also randomly monitored weld parameters and recorded them as follows: welding amperage 287 amps, welding voltage 28.2 volts with a travel speed of 419 mm per minute. The weld parameters appeared to comply with contract requirements. The attached photograph provides additional detail.
